BUREAU OF SHIPS GROUP
TECHNICAL INSPECTION REPORT

⑥ OPERATION CROSSROADS.
U.S.S HUGHES (DD410).
TEST BAKER.

VOLUME II [u] ⑧

USS HUGHES (DD410)

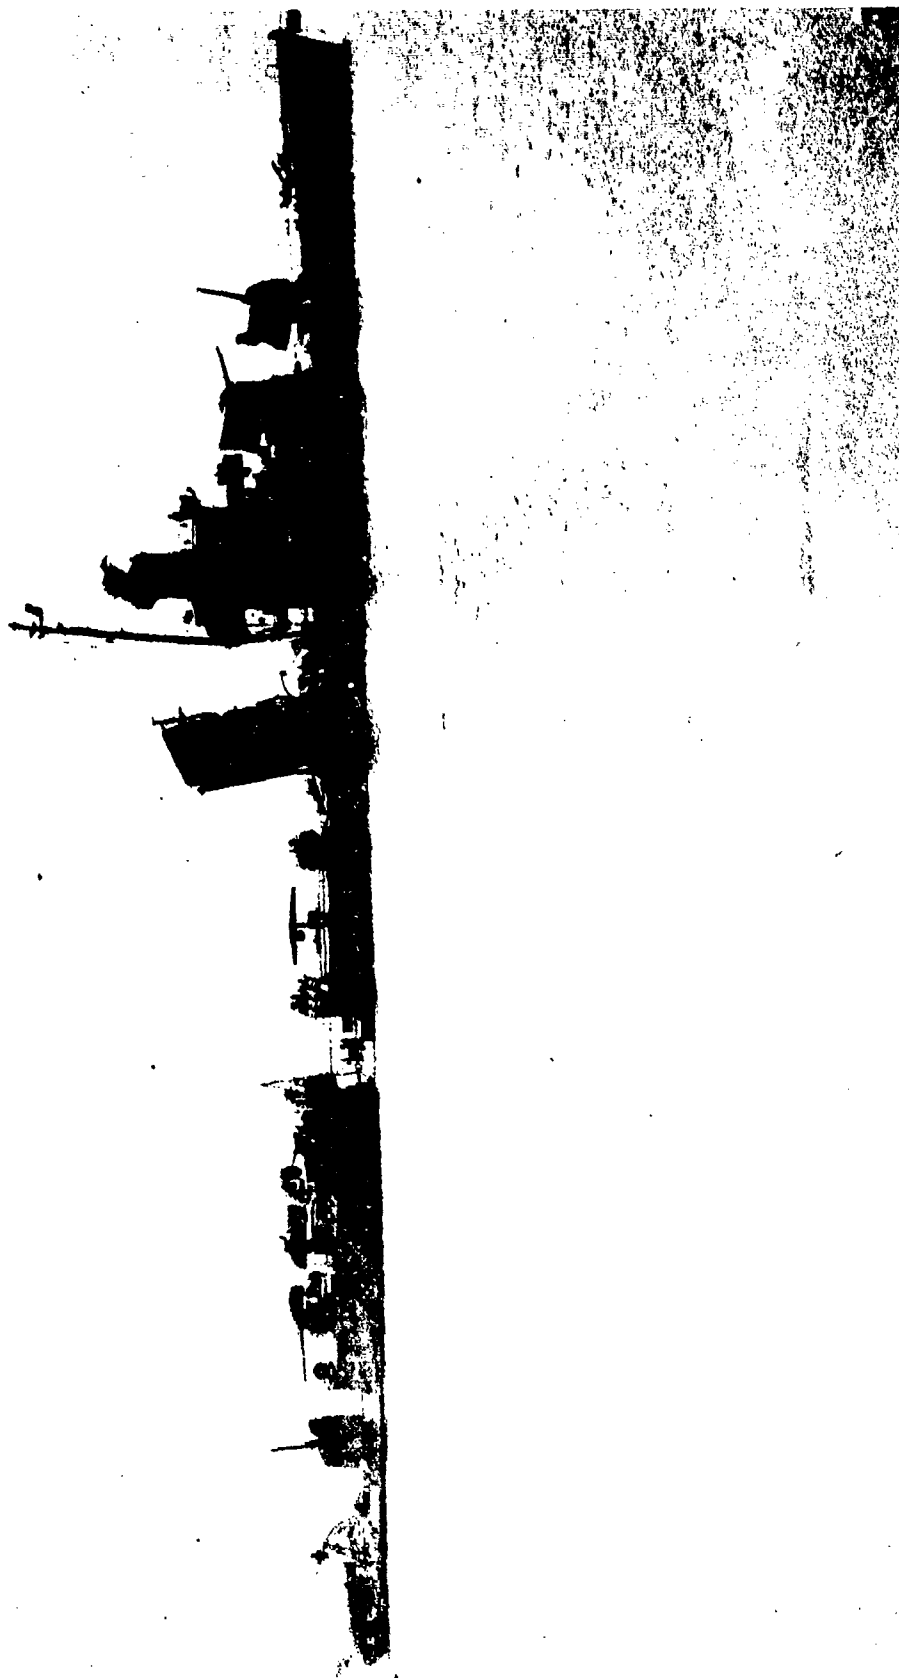
AB-CR-227-290-34. Starboard beam after Test B.

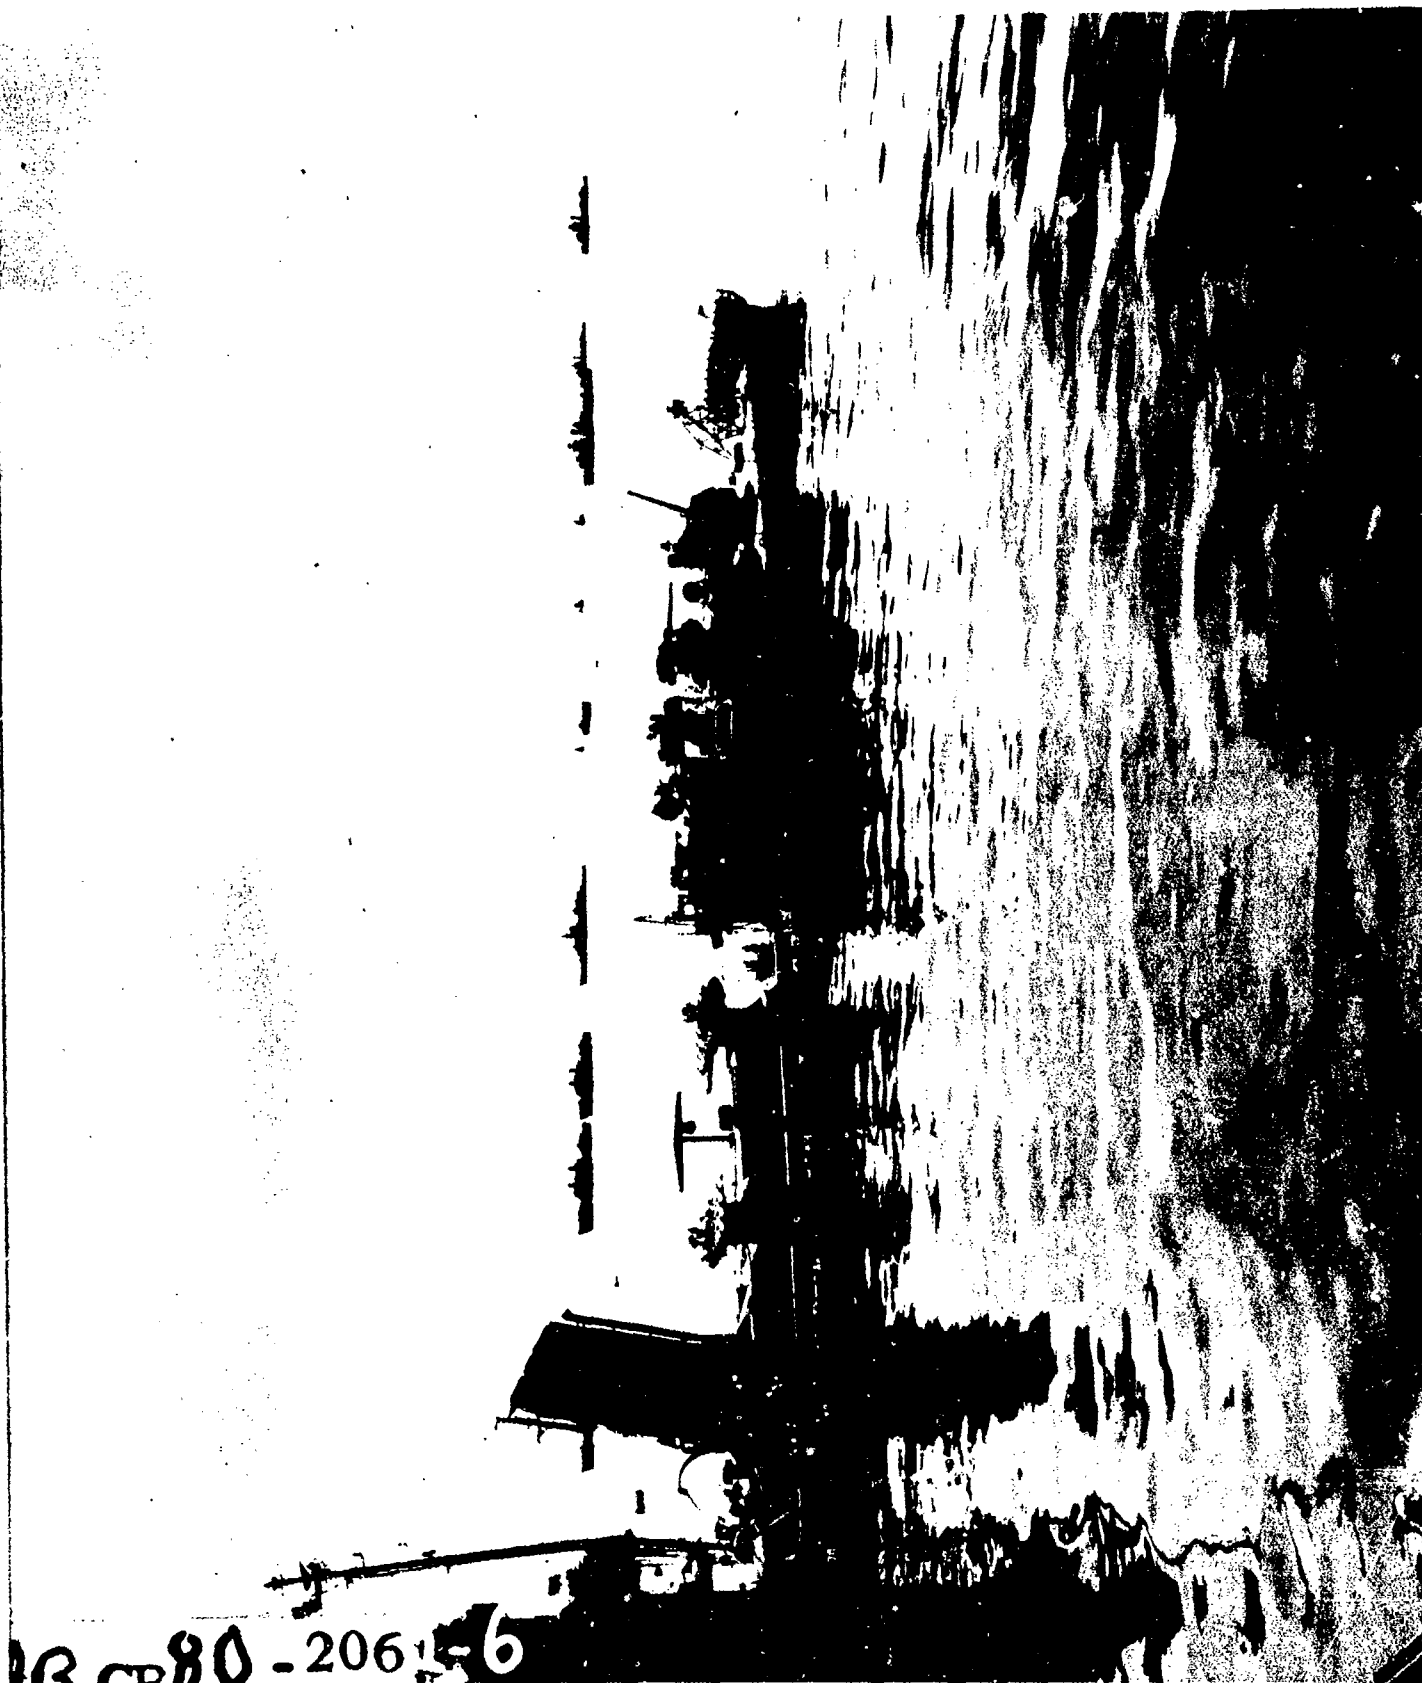
AB-CR-80-2061-6. After superstructure from port beam after beaching.

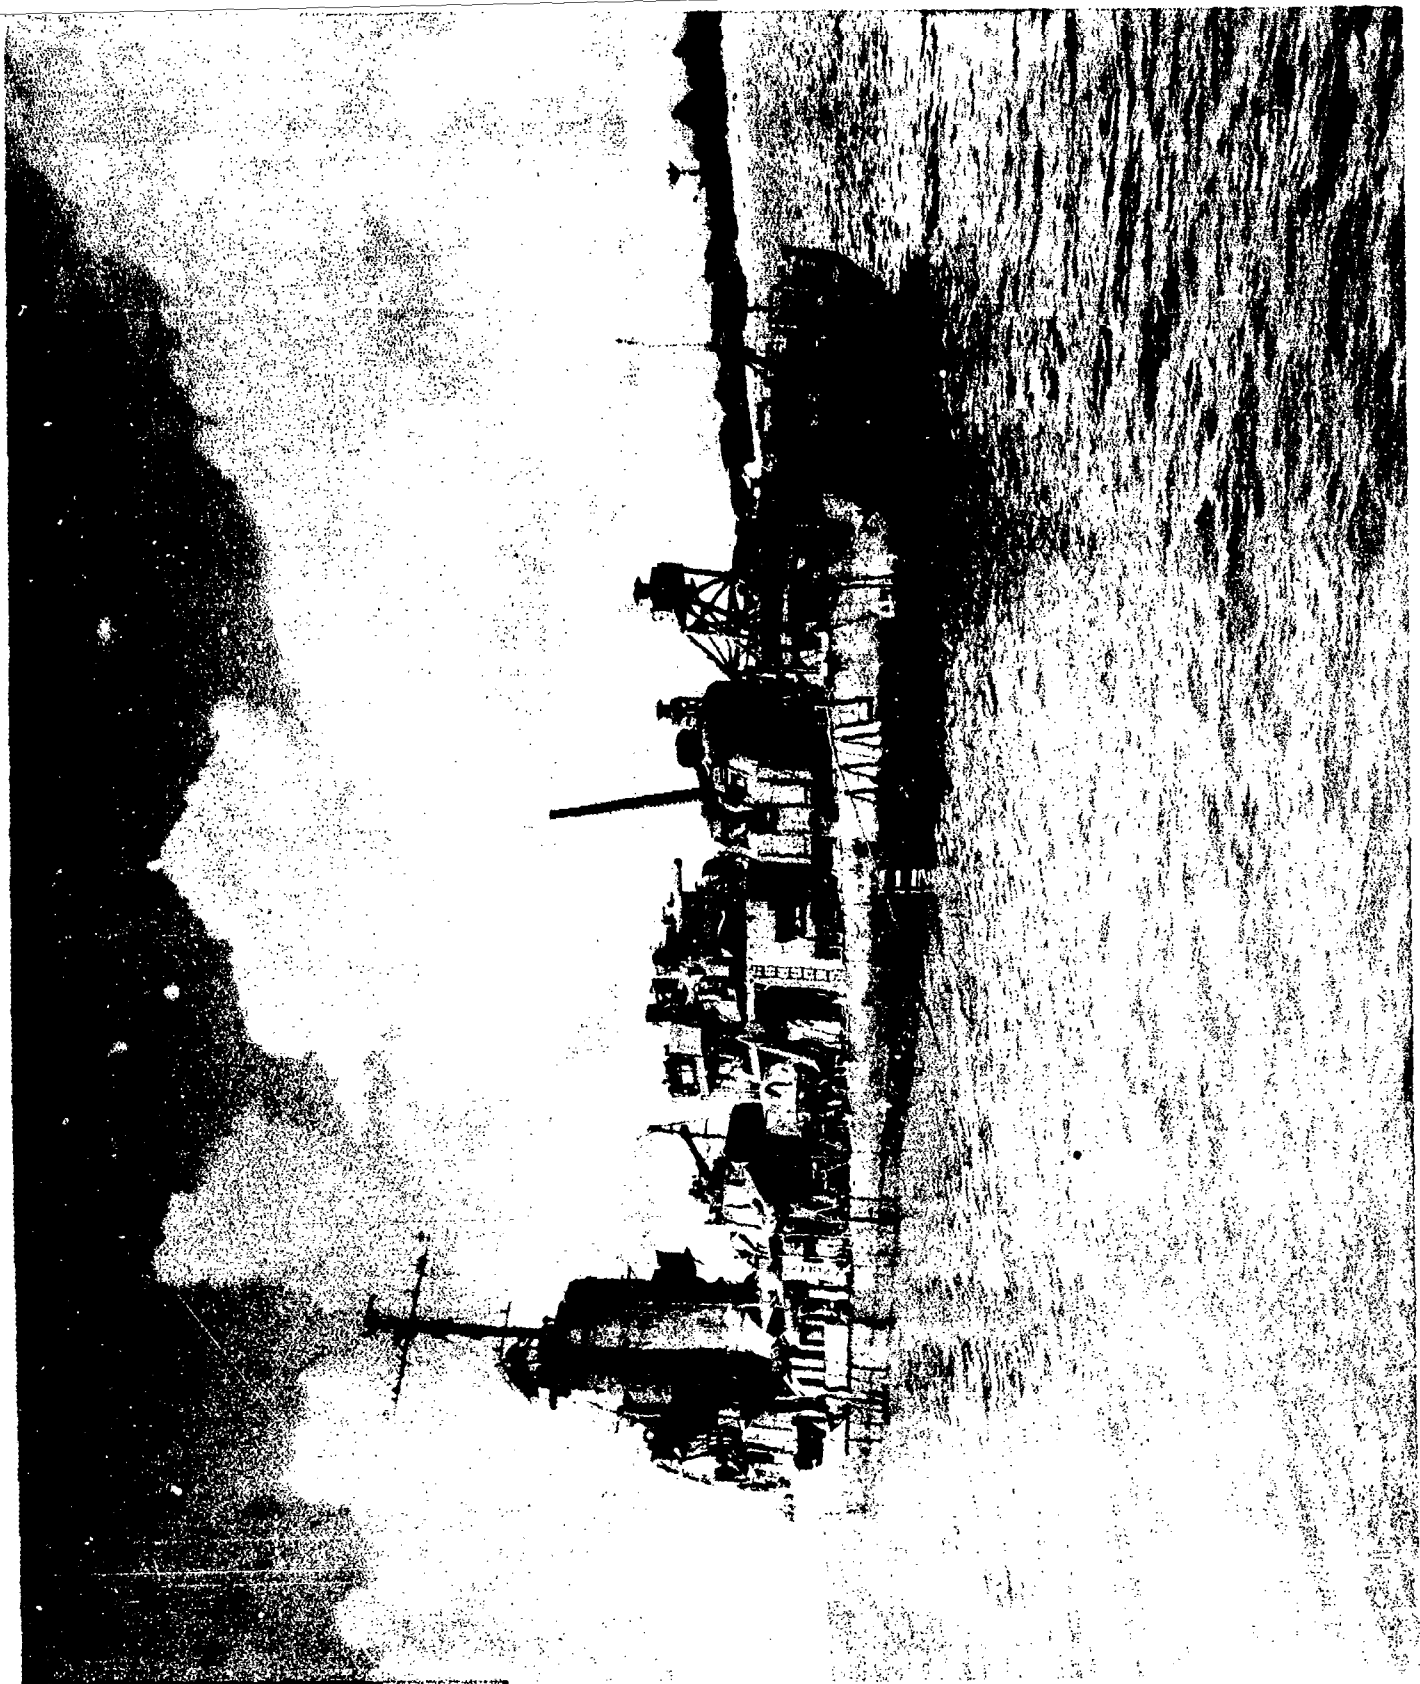
AB-CR-79-2974-5. View of ship after grounding from off port quarter.

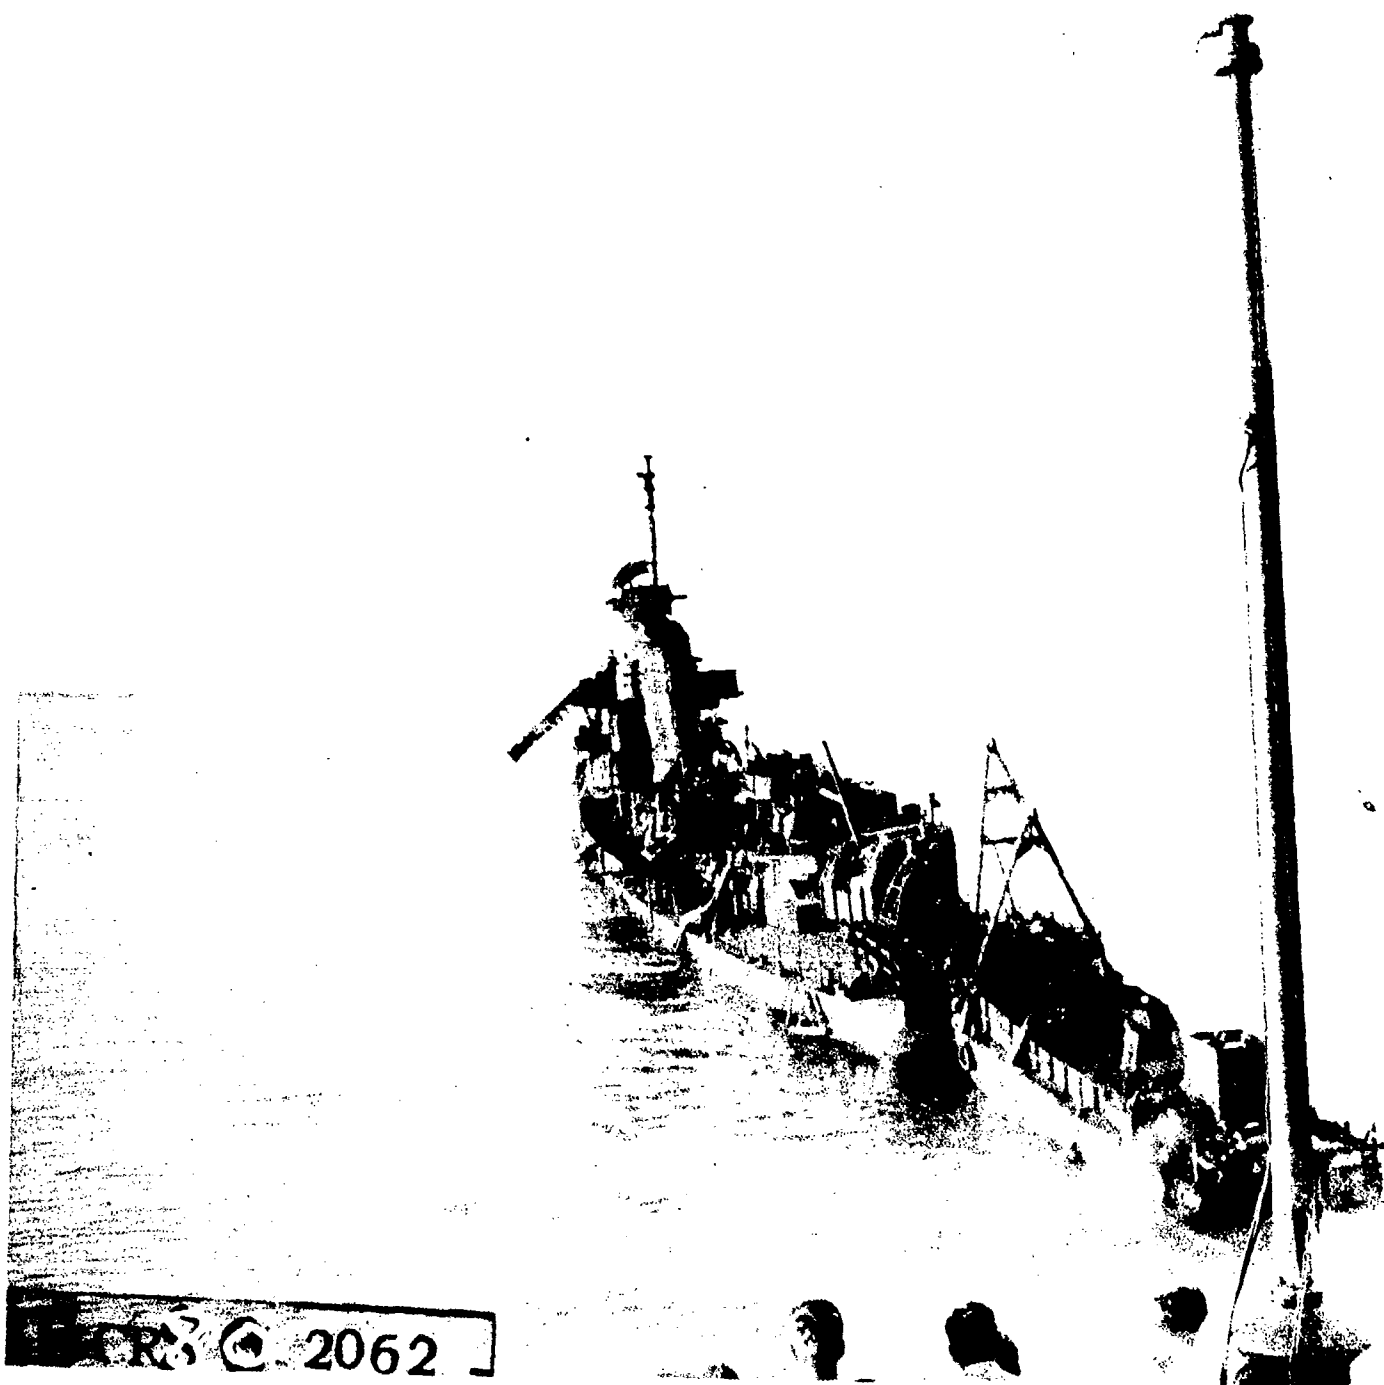
AB-CR-80-2062-6. View of superstructure from stern to port, during beaching operations.

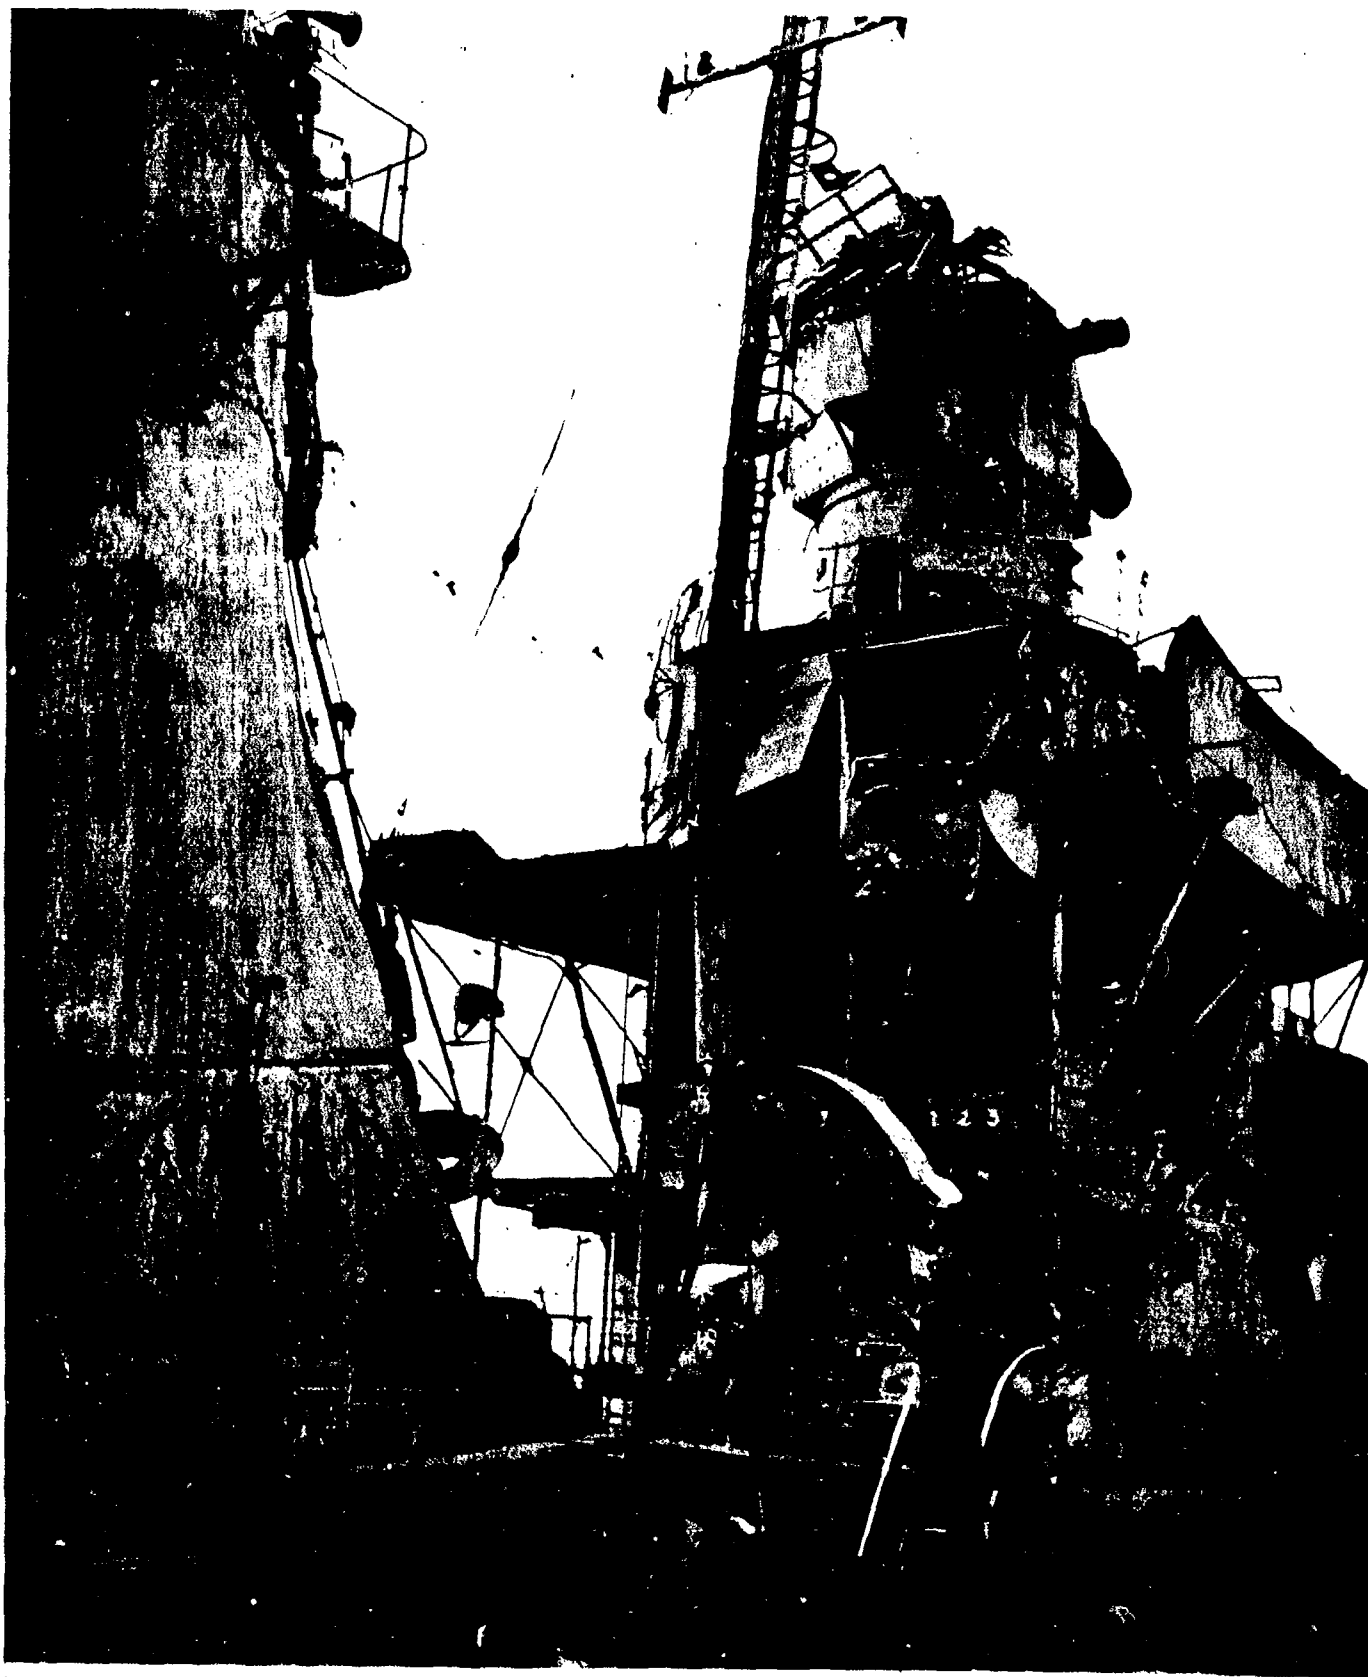
AB-CR-76-2076-12. Starboard and after faces of forward superstructure looking forward and to port. Port flag bag is carried away.

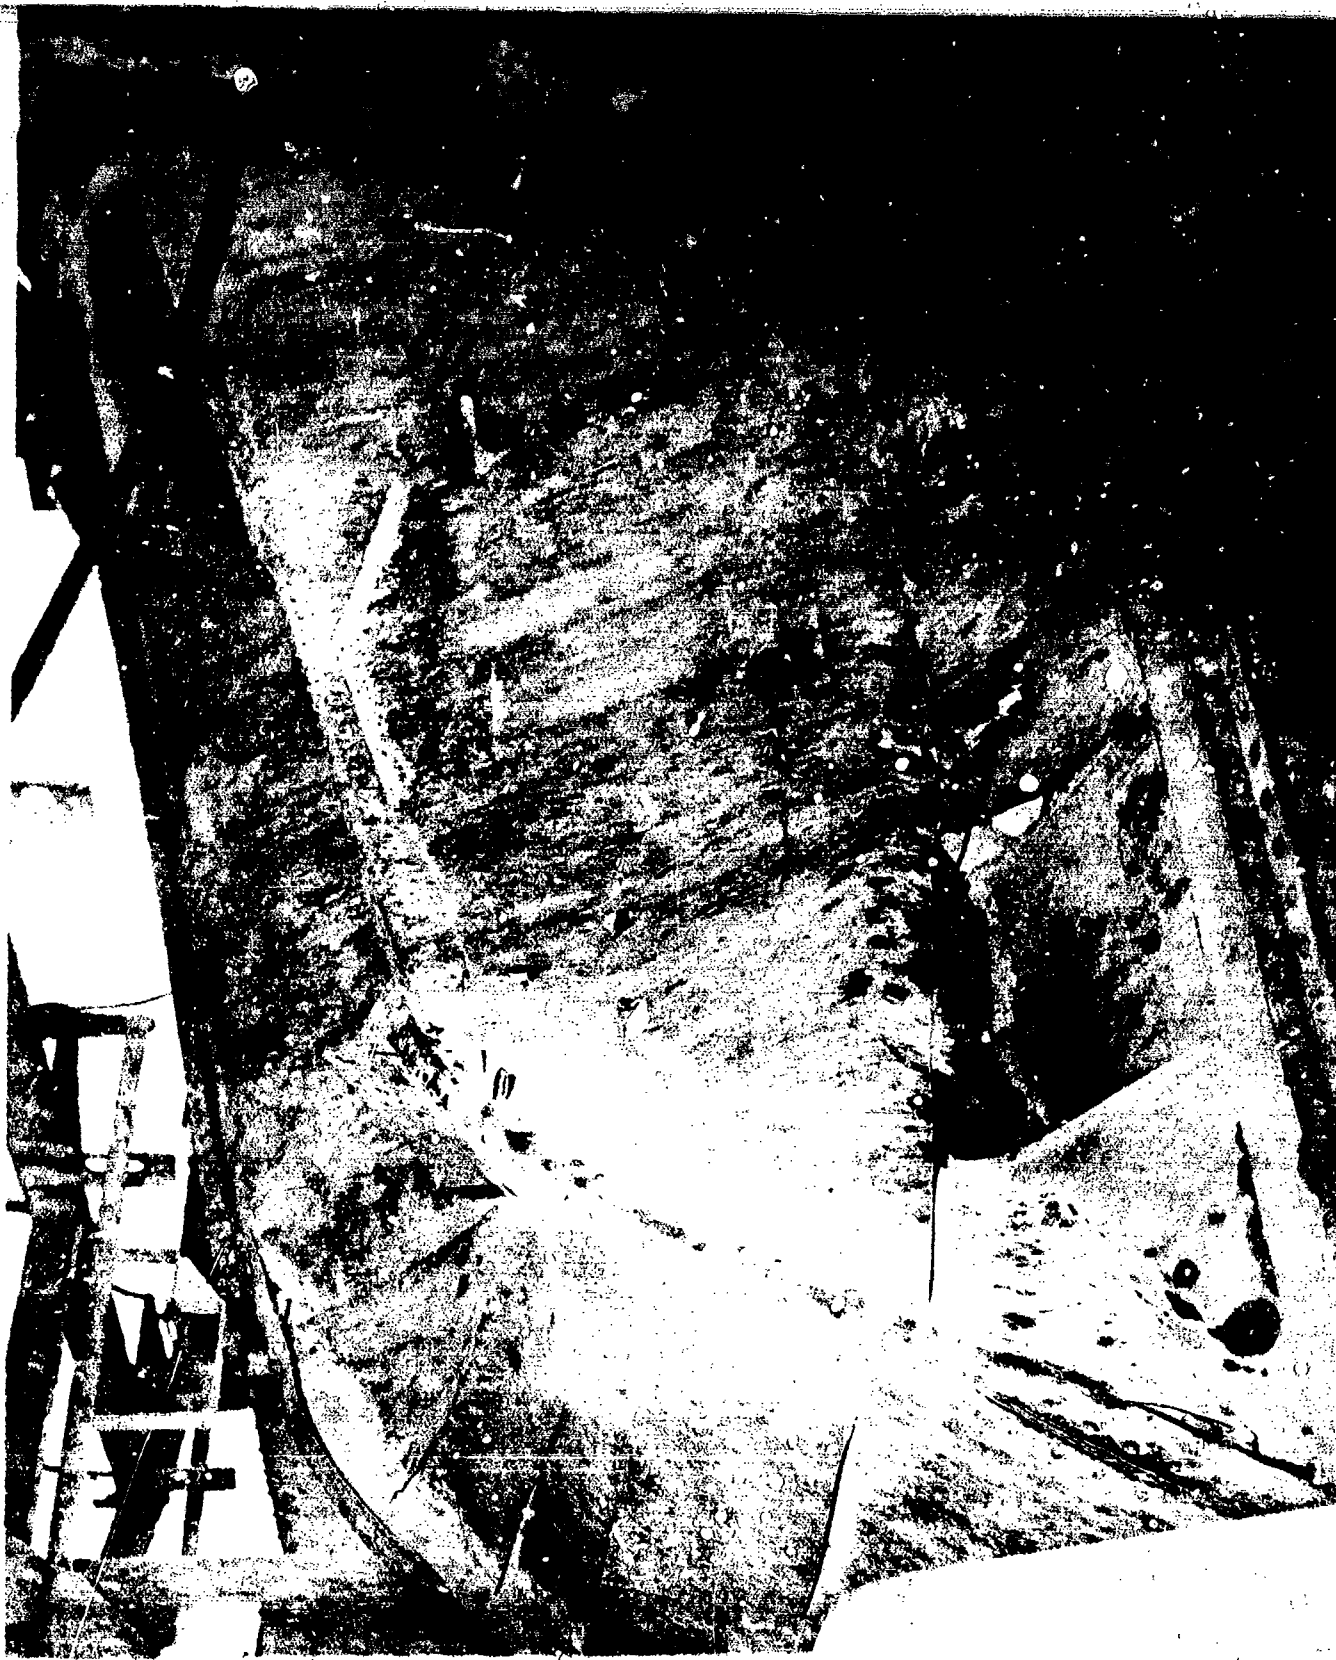
AB-CR-76-2077-4. Damage to starboard side of No. 3 boiler uptake.

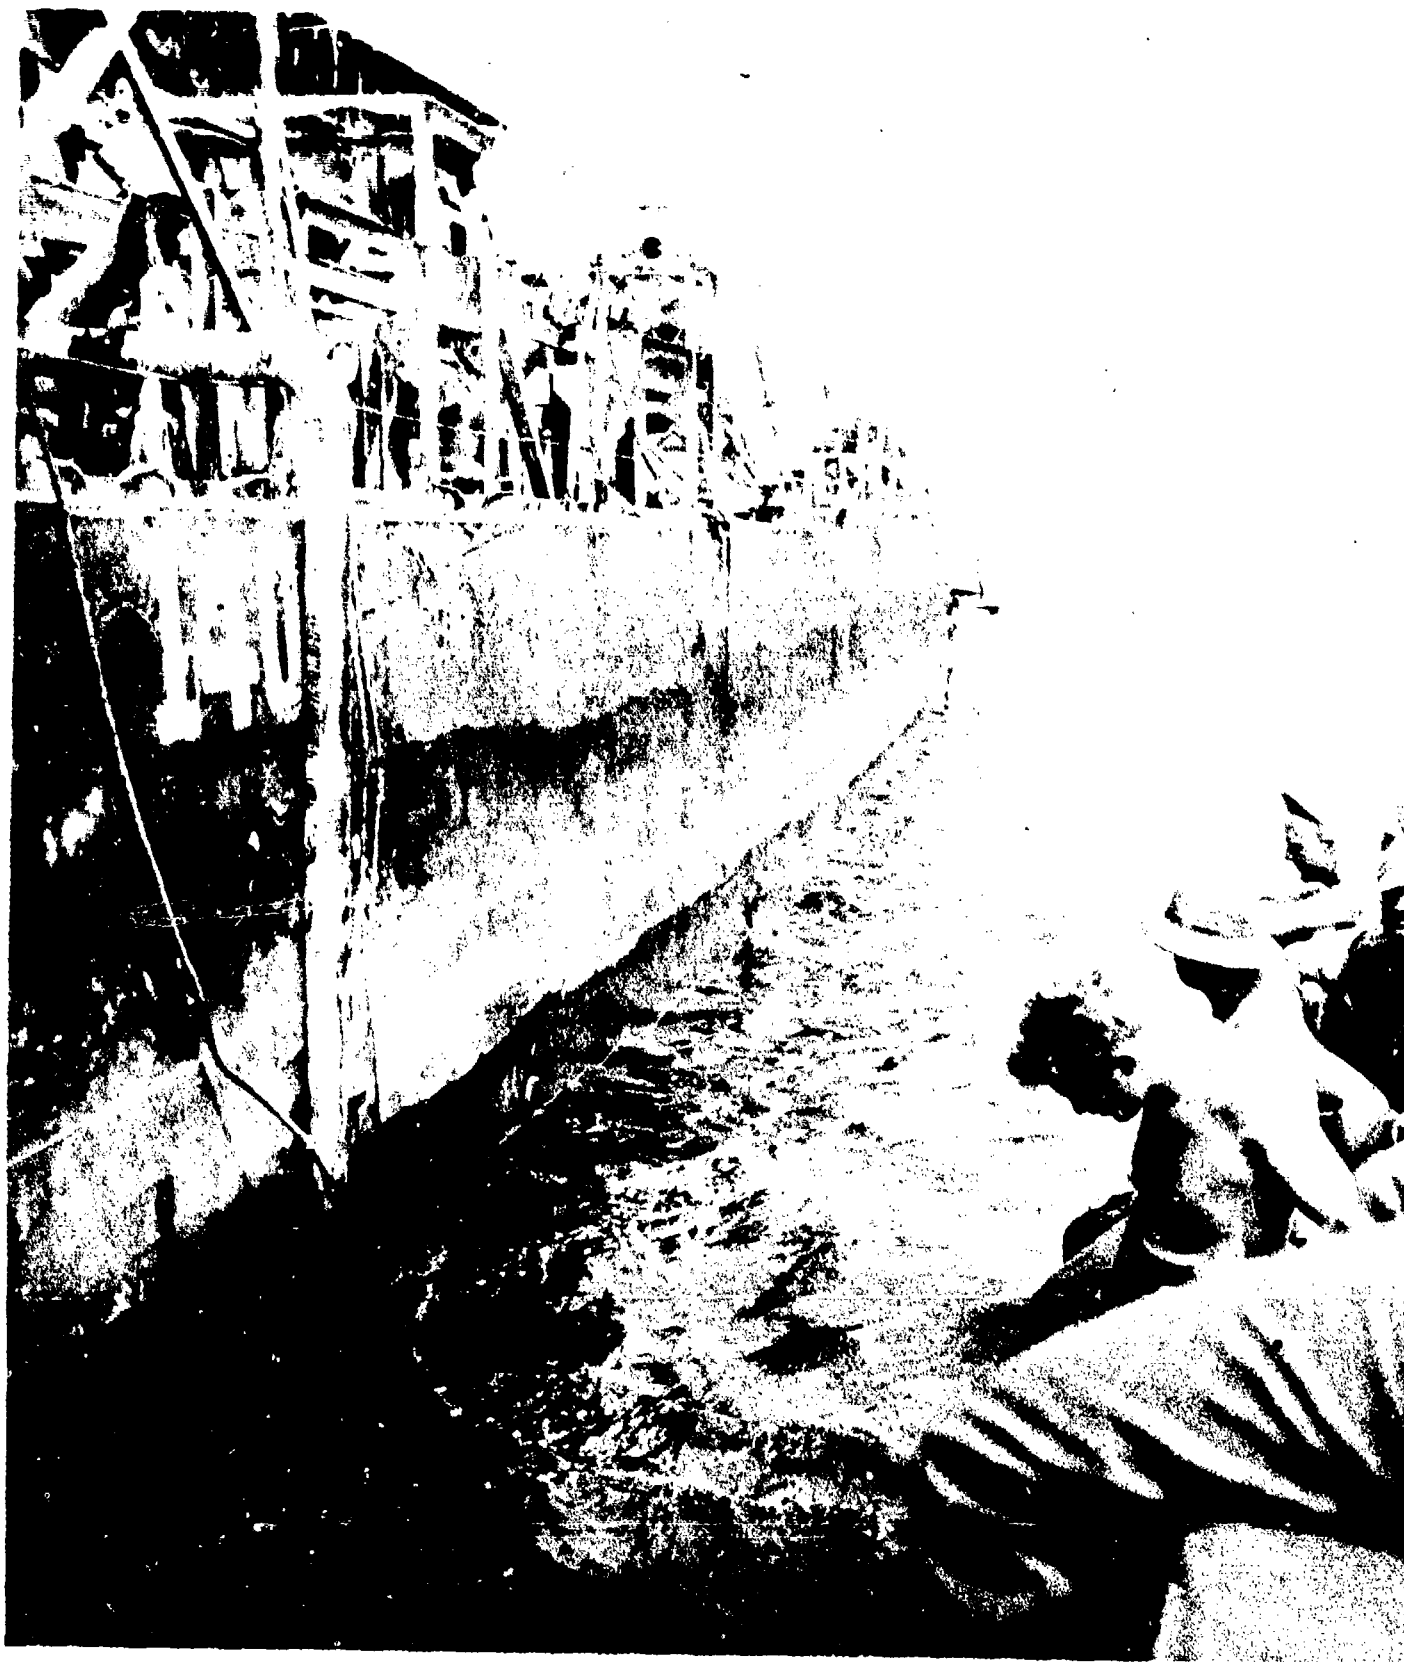
AB-CR-100-4211-11. Port shell, looking aft from frame 140.

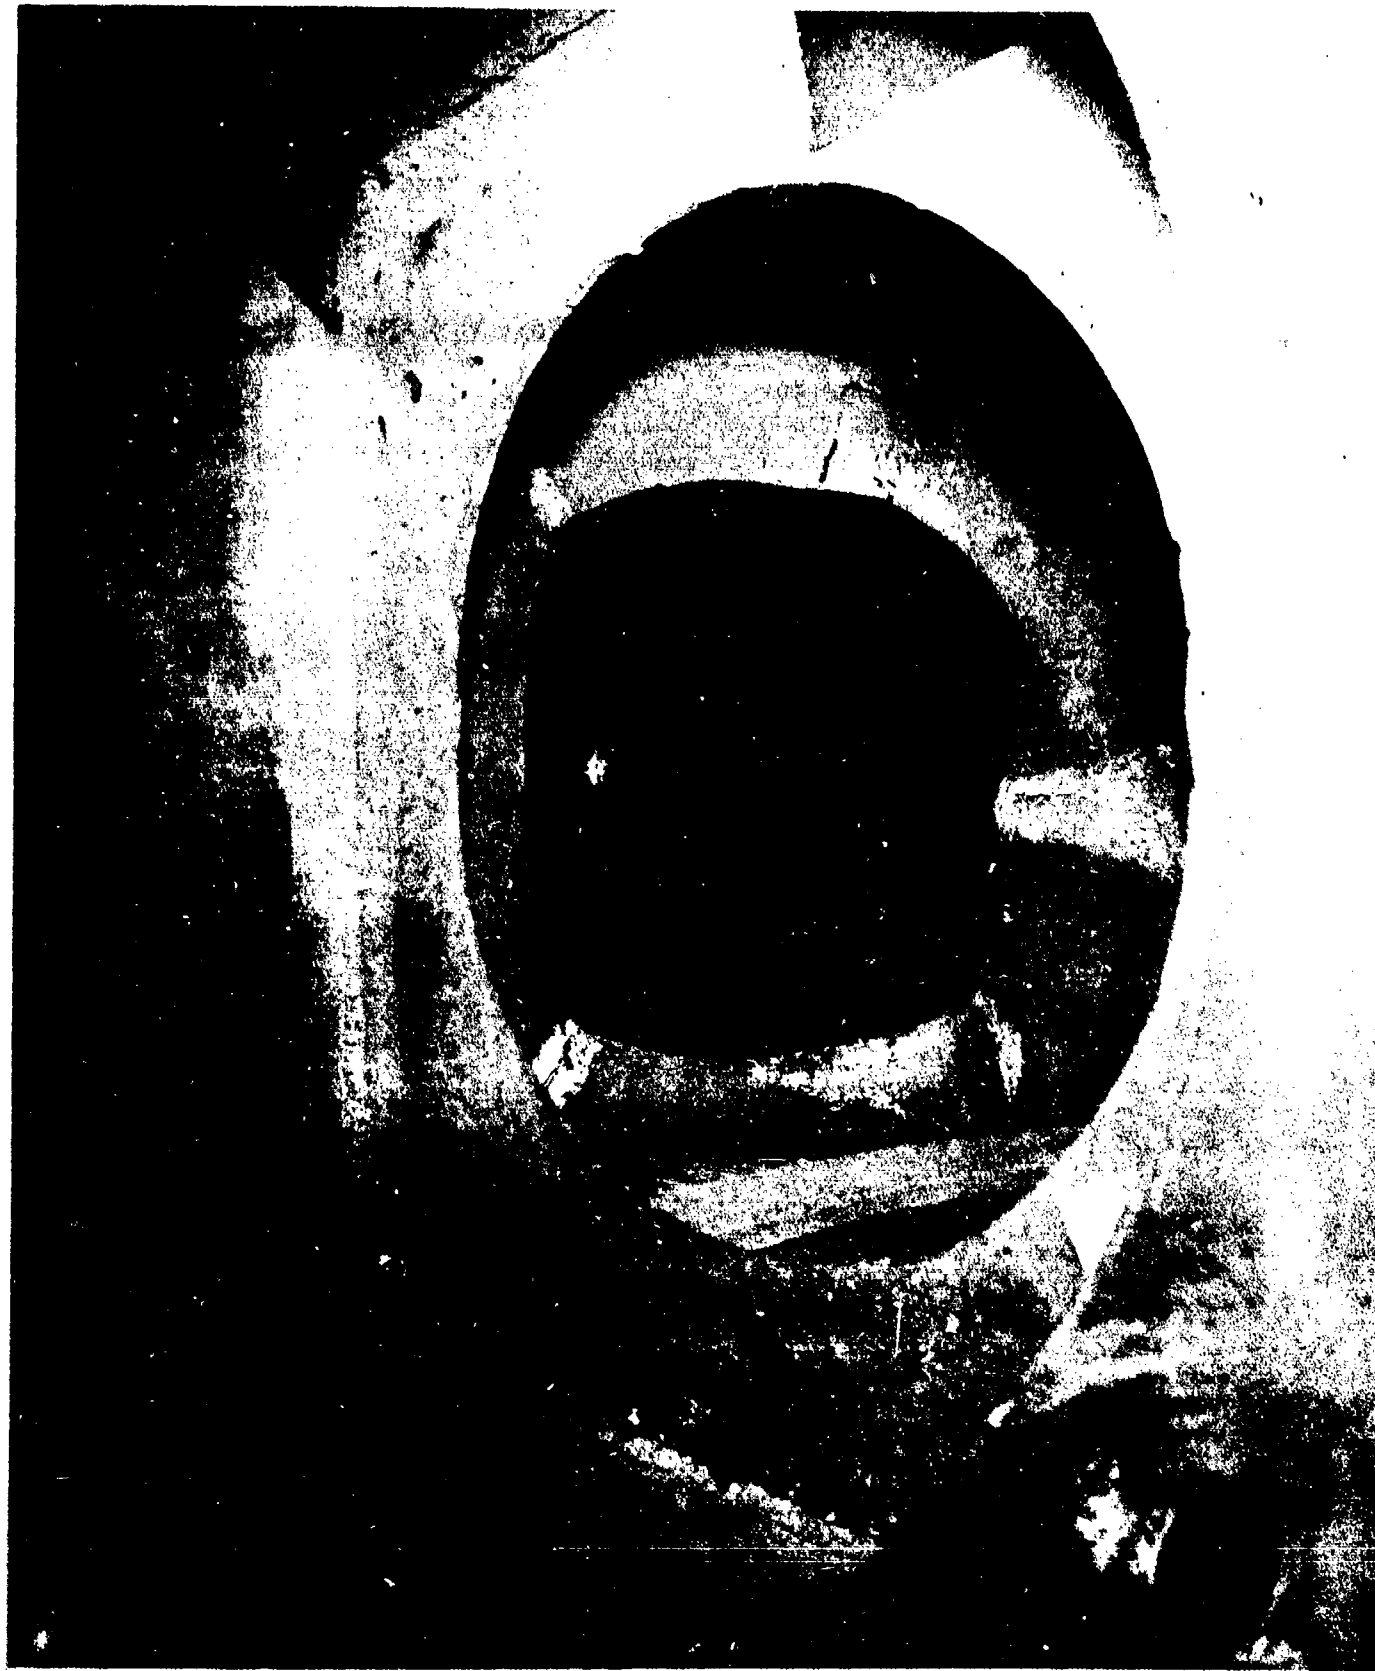
AB-CR-234-4062-10. A-1W. Buckling of floor in peak tank at frame 3, looking forward.

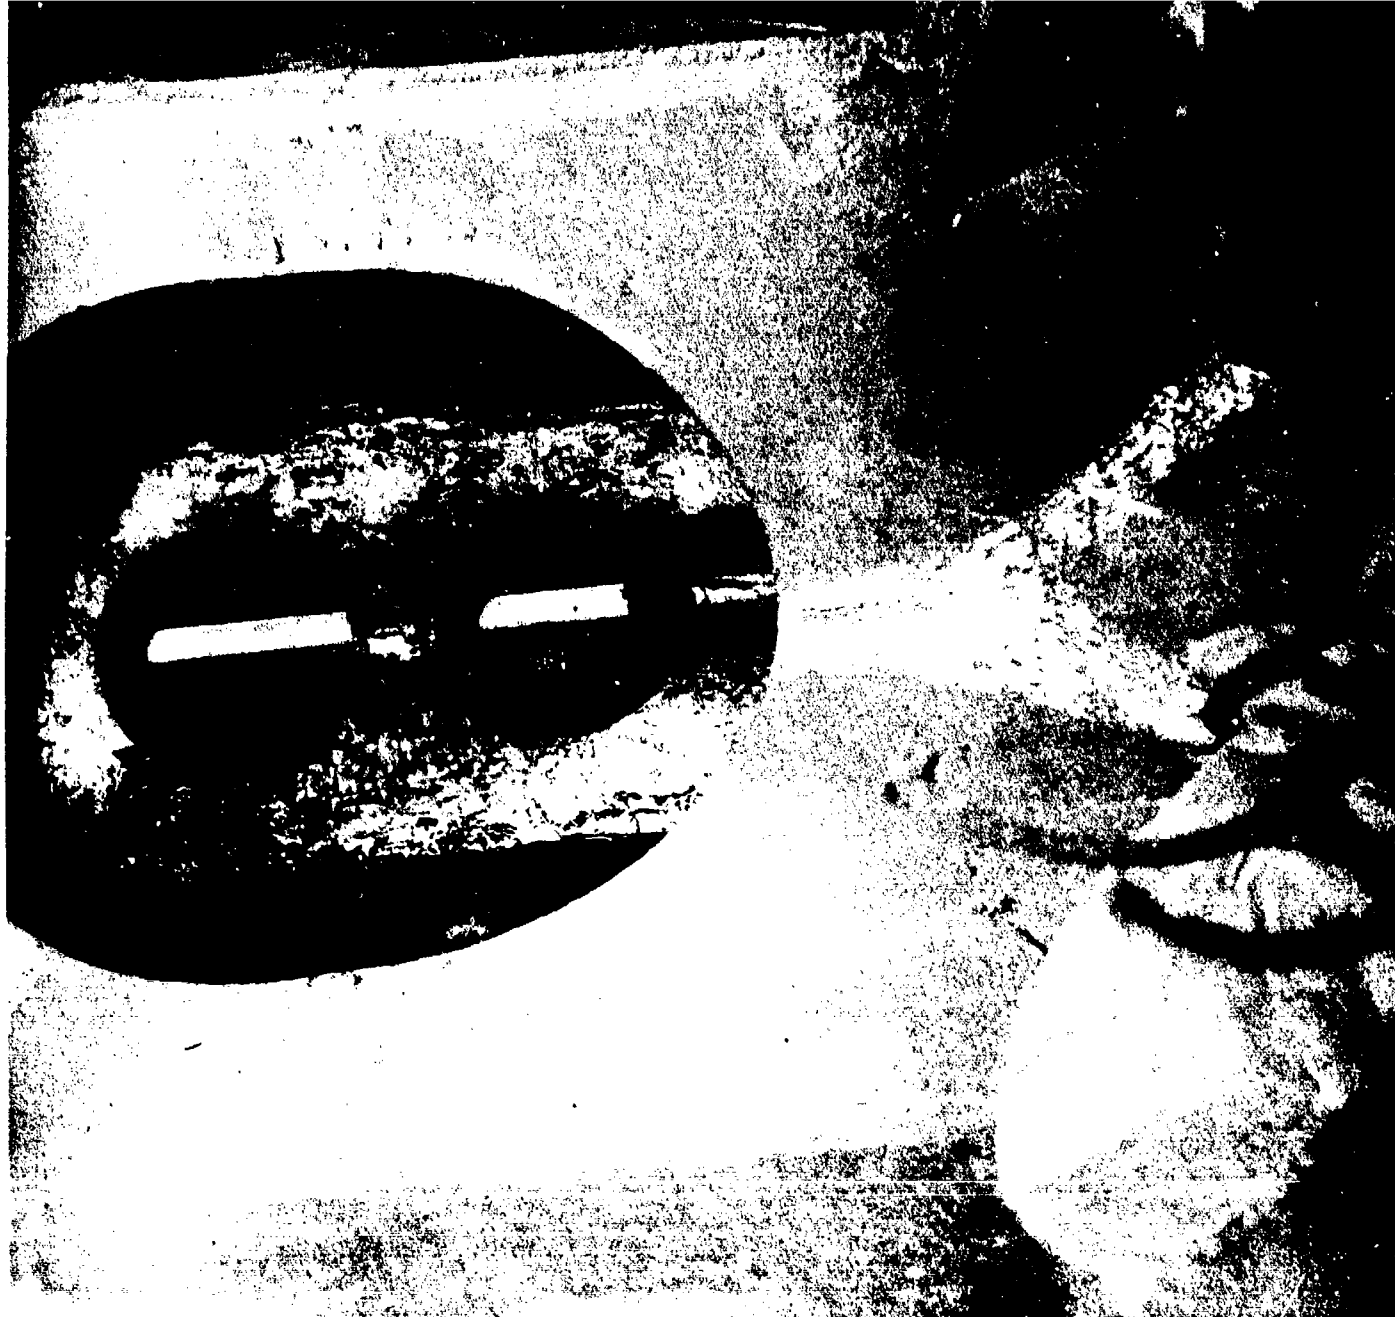
AB-CR-234-4062-6. A-1W. Looking forward in peak tank showing buckled floor at frame 3.

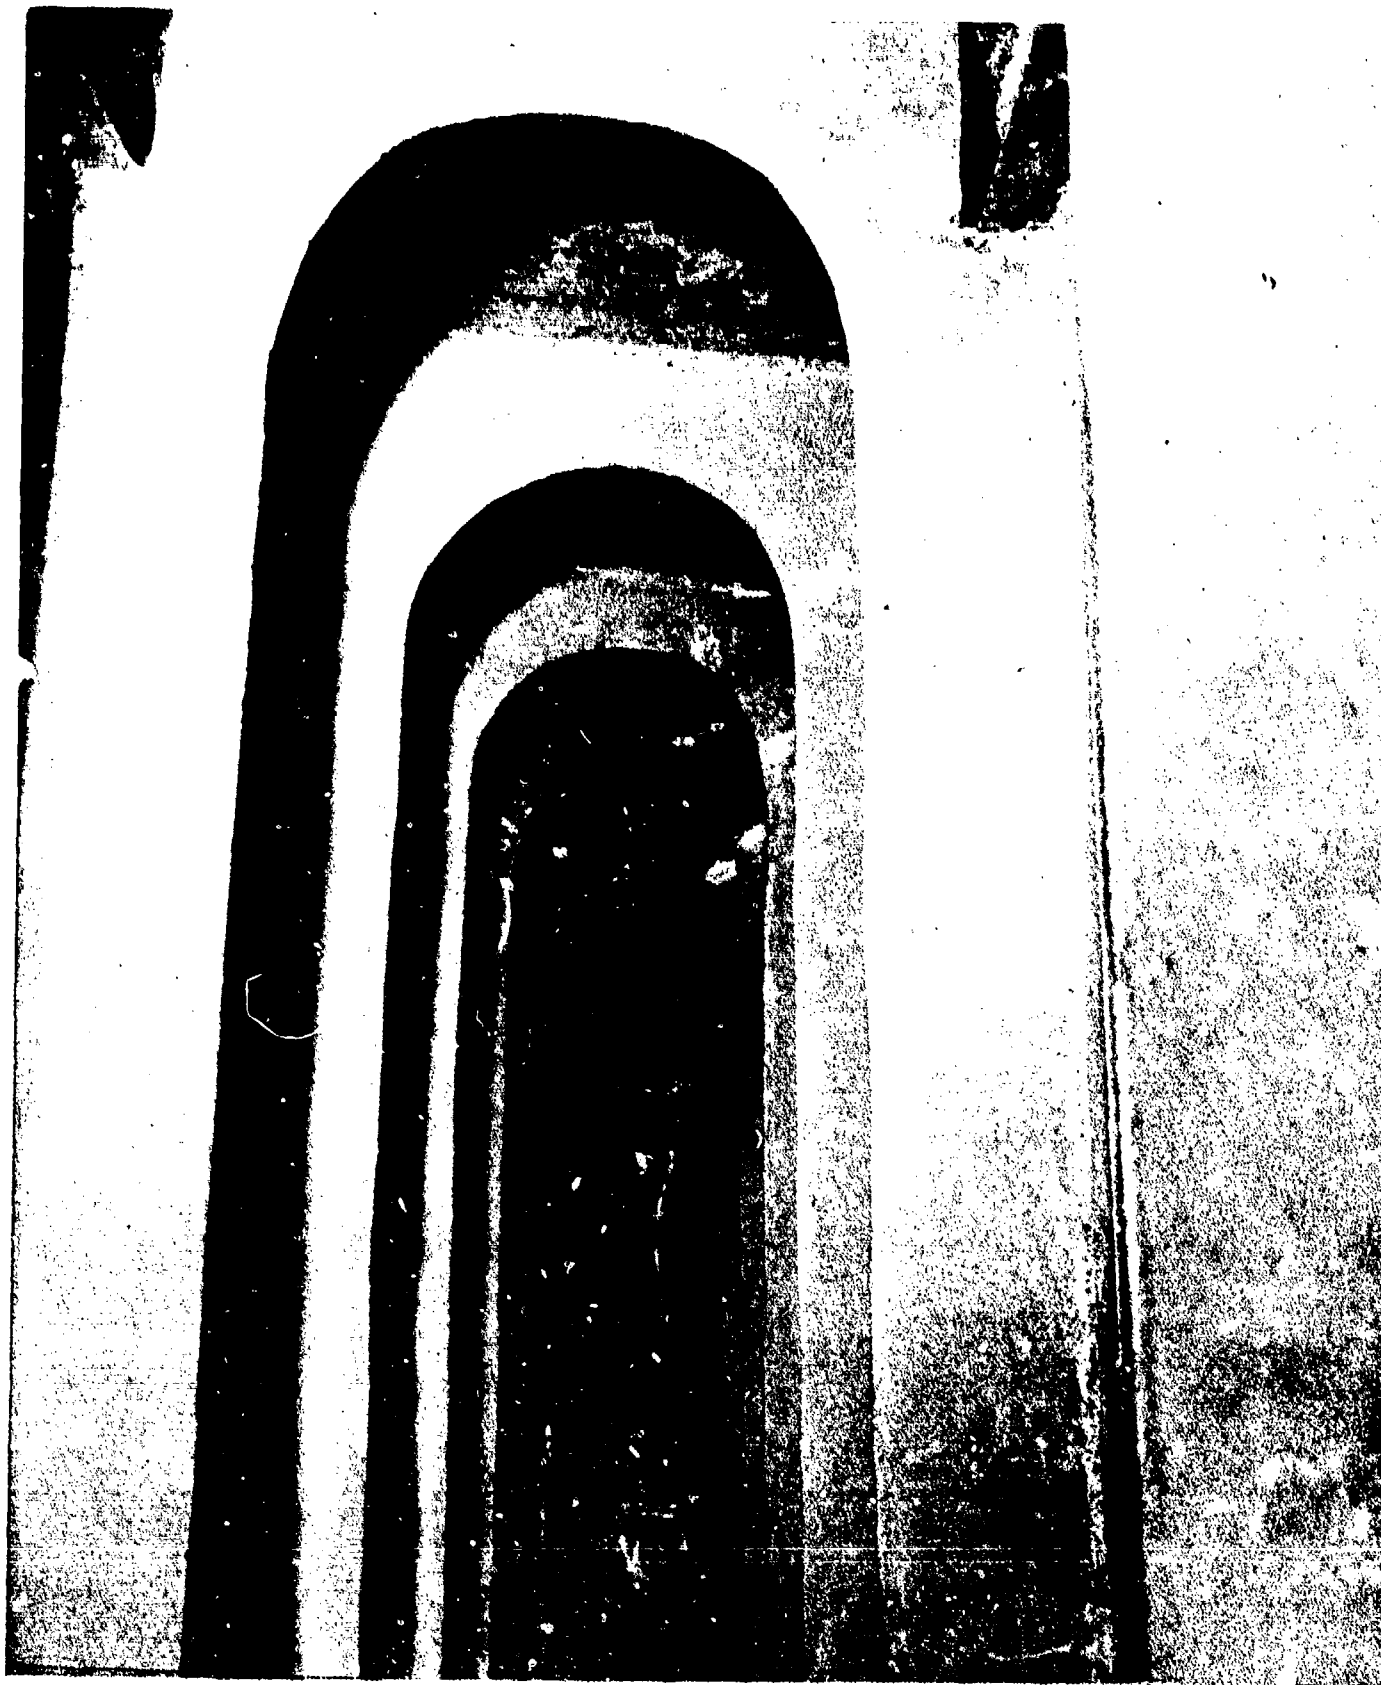
AB-CR-234-4061-1. A-401W. Buckling of floors in peak tank, bulkheads 6 to 14, looking aft about 6 feet above keel.
